Martin A. Benassi, AIA  
Architect LLC

## 505 Hudson Street Hartford, CT

### Exterior Envelope Repairs

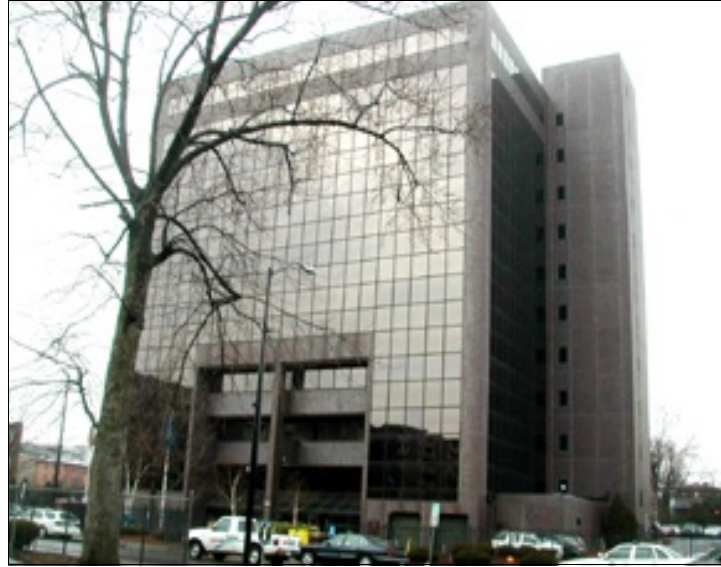
The 10-story steel-framed building is clad with a glass curtain wall and prefabricated panels of a thin-brick composite. The panels provide the illusion of a full brick veneer at a fraction of the cost and weight.
